Maryland Inventory of Historic Properties <u>Addendum</u>

MIHP Number: WA-IV-023

Gardenour Fruit Farm

INVENTORY FORM FOR STATE HISTORIC SITES SURVEY

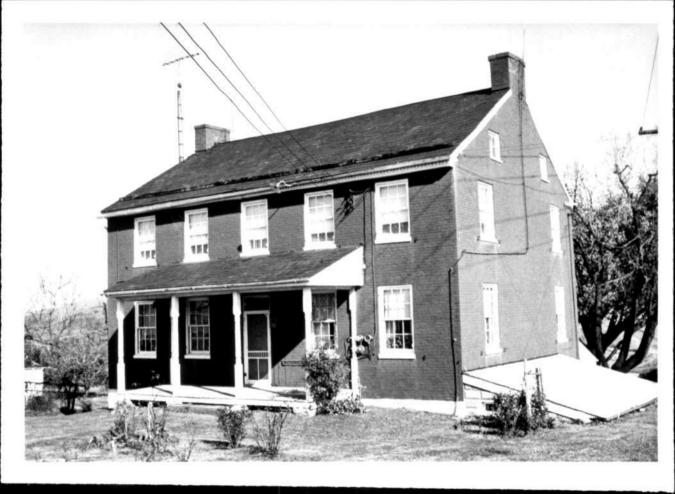
WA-IV-023 S.W. Nov. 1916 Gardenour Fruit Farm

This two and one half story five bay brick house is part of a farm complex which is now within a large orchard. The house is constructed with Flemish bond at the front elevation and common bond at the side and rear wall. The entire surface of the building has been painted red. All windows have six over six pane sashes. Above the central front door is a transom with diamond shaped panes. The east or rear elevation of the house is a full three stories high. Behind the house is a brick spring house and numerous other outbuildings. Also present is a large frame bank barn.
